HYDRAULIC RAM EFFECT ON
COMPOSITE FUEL CELL ENTRY WALLS

THESIS

by
Alfred Nicholas Duva Jr.

March 1976

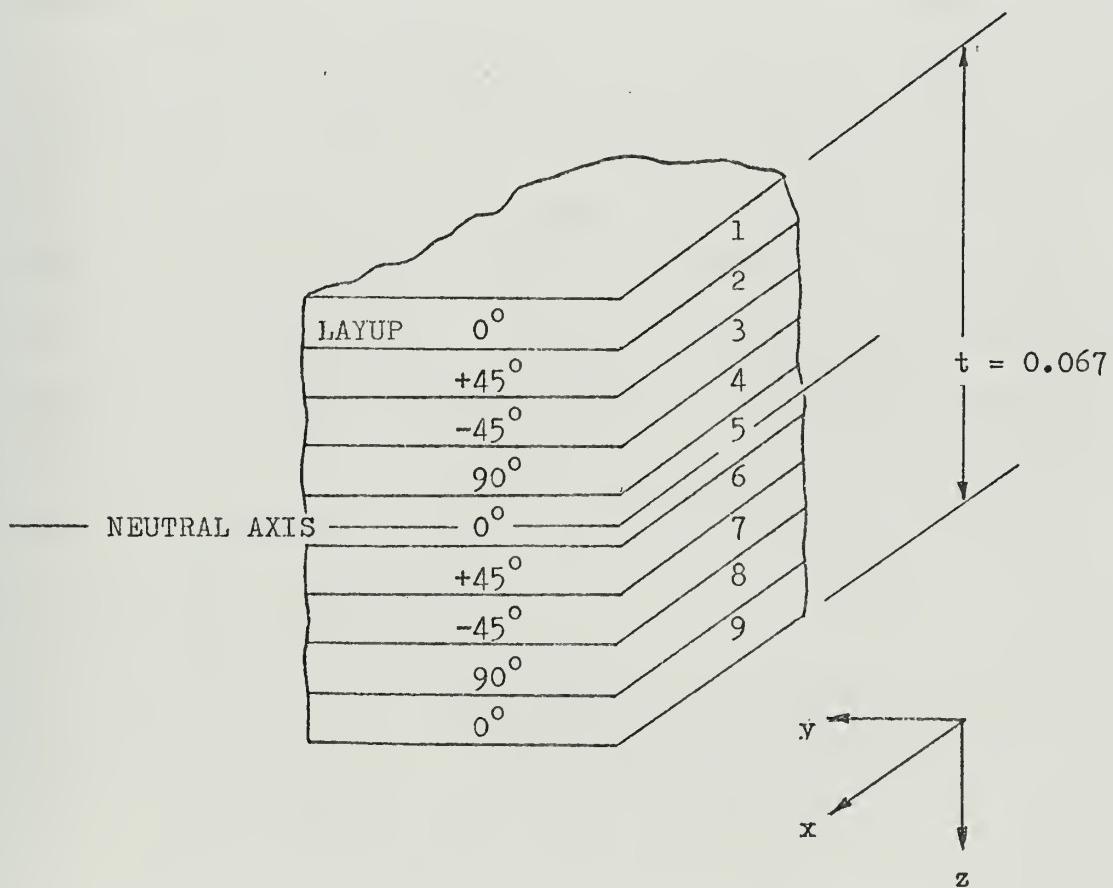
FIGURE III.A.1 - Test Laminate

The dimensions of antisymmetric angle-ply test laminates were 12 by 12 by 0.067 inches. Visual examination of the test plates revealed overall warping and considerable delamination. This condition, directly effecting the strength and stiffness of the laminate, may be attributed to an improper curing process.

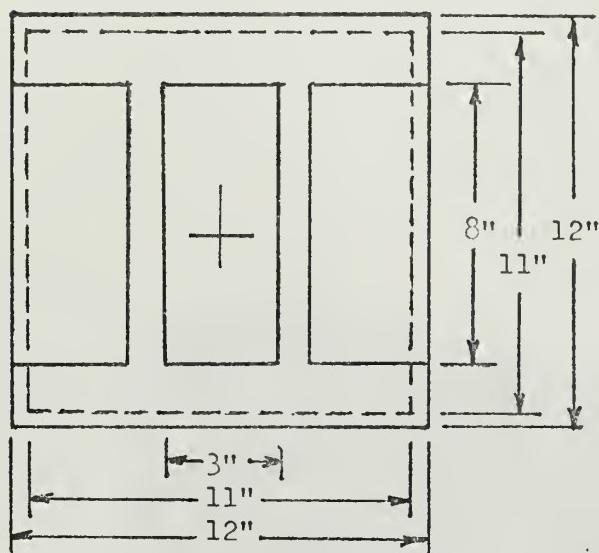
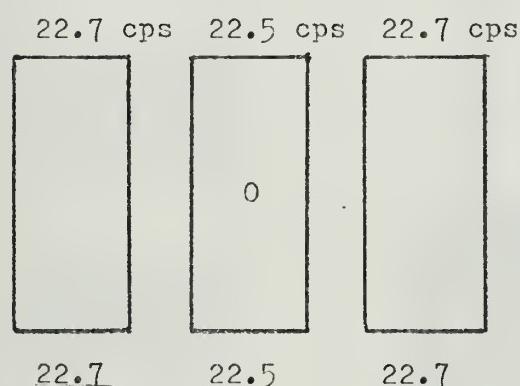
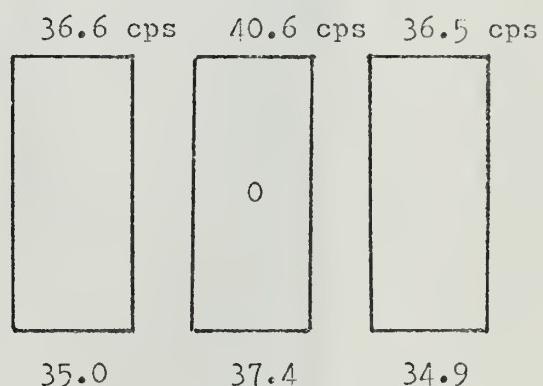
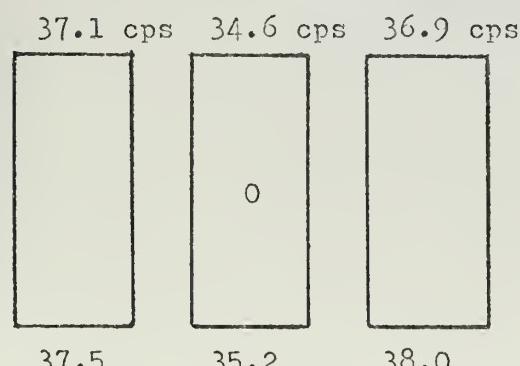
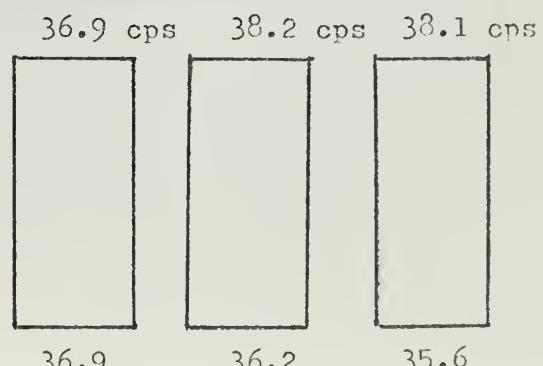
Figure V.C.1 - Plate Vibration Test Specimens

When comparing the frequency of the center strip to that of the end strips of each plate tested, the following was observed: no significant frequency deviation of the aluminum plate (ballistic penetration with hydraulic ram) and the undamaged composite laminate (no ballistic impact); a 6-7 percent frequency decrease of the composite laminate subjected to ballistic penetration (no hydraulic ram); a 9 percent frequency increase of the composite laminate with both ballistic penetration and ram effect. Visual examination of the last laminate indicated probable delamination of the end strips caused by the clamped edge boundary damage.
